January 12, 2023

RE: Coal Combustion Residual (CCR) Landfill Annual (2022) Inspection
 Clear Spring Ranch
 Fountain, Colorado
 Terracon Project No. 23155030

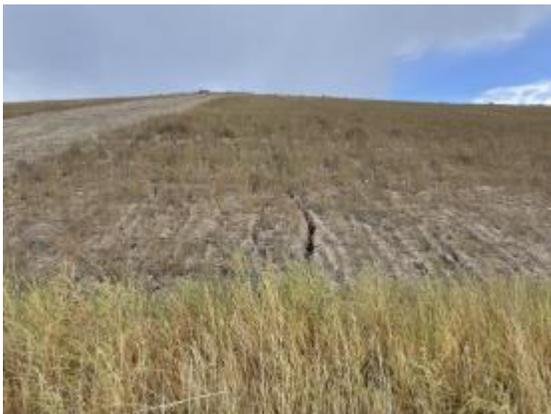
Photo No. 5

During our initial site visit, we observed a significant amount of erosion rills and gullies along a portion of the southern slope. Most of the erosion features were about 6 to 10 inches deep. The areas of erosion rills were located at the south facing slope surface in the southeast area of the fly ash portion of the landfill (see Photo Nos. 5 to 20 in the attached photography log).

- Four areas along south facing slope and east facing slope at the southeast corner developed localized areas with rills extending up to 10 inches through the 12-inch soil cap. These areas should be regraded to establish a uniform 12-inch soil cap.
- The primary containment berms along the base of the south and north facing slopes have significant sediment build-up on the upslope side, thereby limiting future capacity associated with precipitation events. We recommend removing the sediment and reshape the berms to increase future sediment capacity.

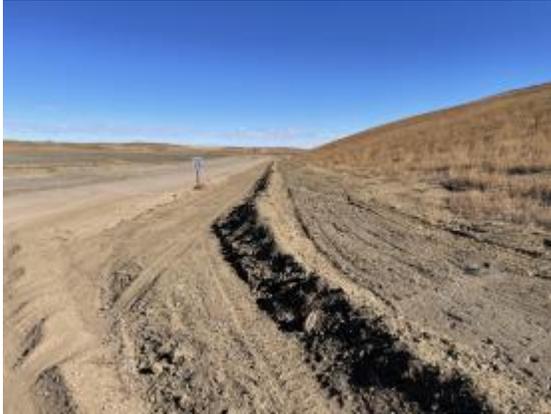
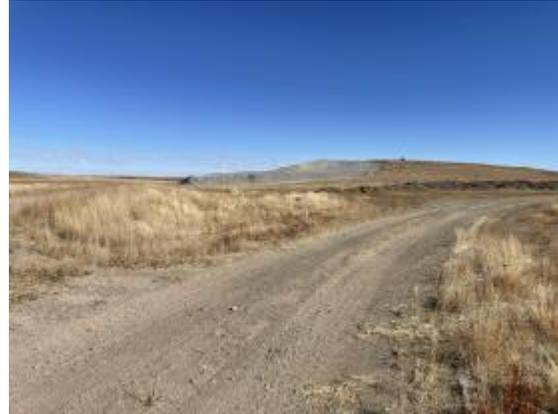
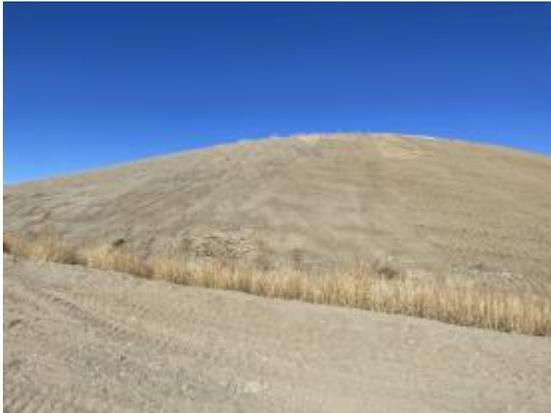
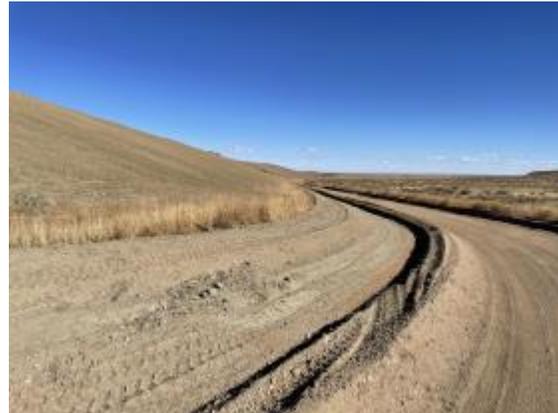
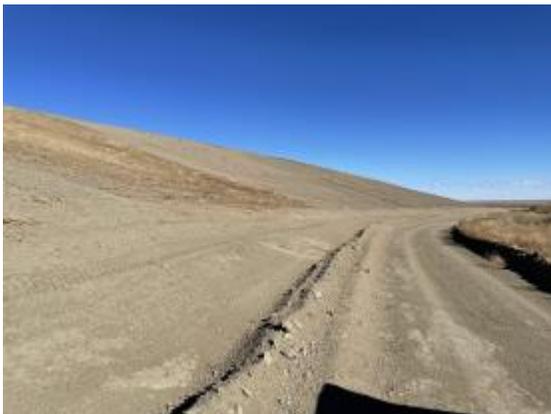
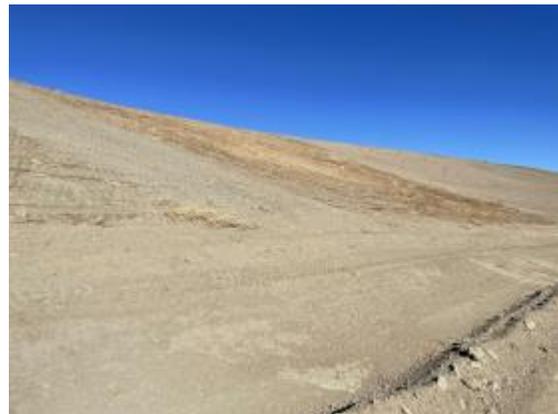
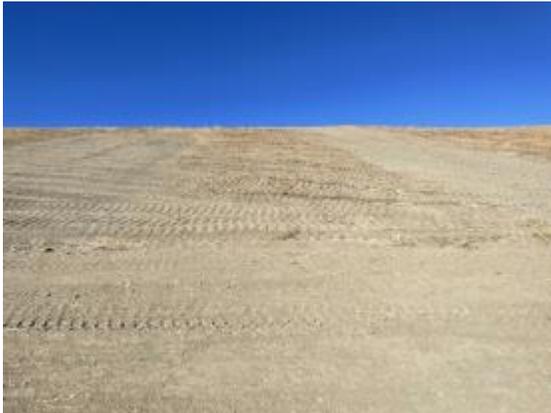
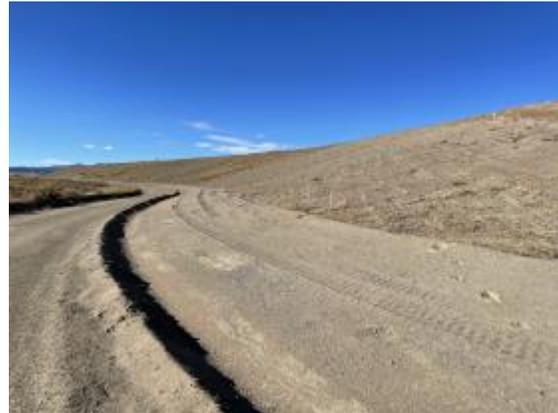
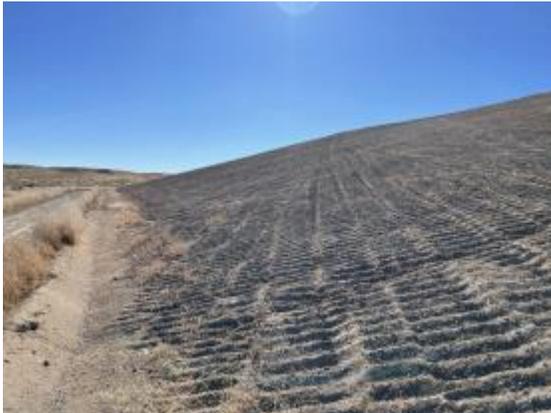
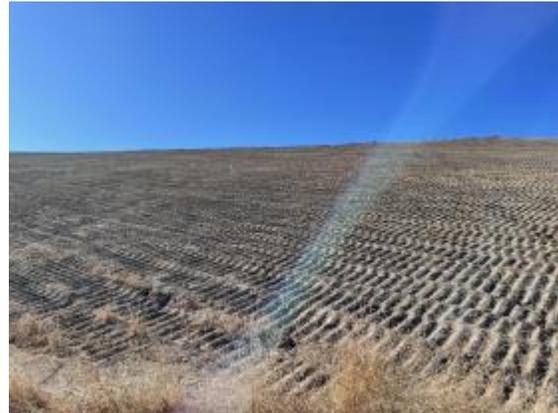
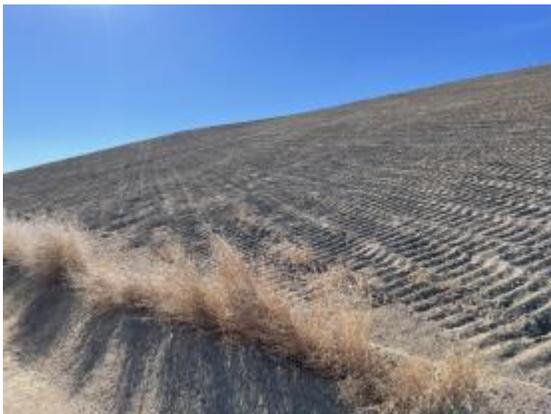
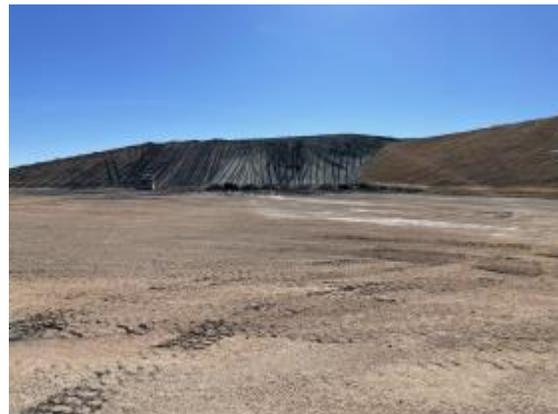
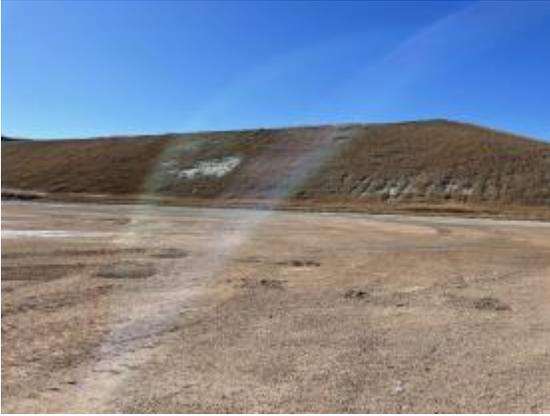
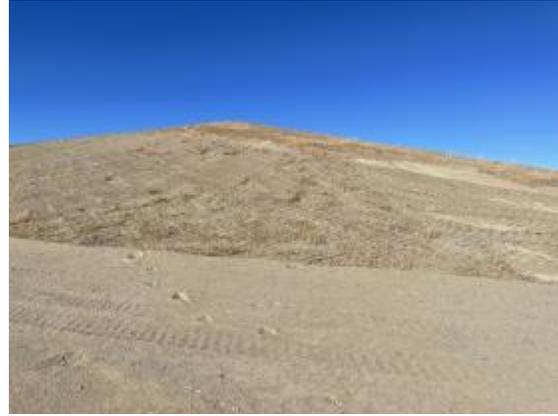
On November 16, 2022, Terracon completed a second site visit and observed the southern slope had been regraded to fill gullies, and north and south containment berms

had been cleared and/or rebuilt. Photo Nos. 57 - 70 show the deficient areas described in the Observations Section of this report had been repaired.
