January 17, 2022

Re: Coal Combustion Residual (CCR) Landfill Annual (2021) Inspection
Clear Spring Ranch
Fountain, Colorado
Terracon Project No. 23155030

CCR LANDFILL ANNUAL INSPECTION

CLEAR SPRINGS RANCH

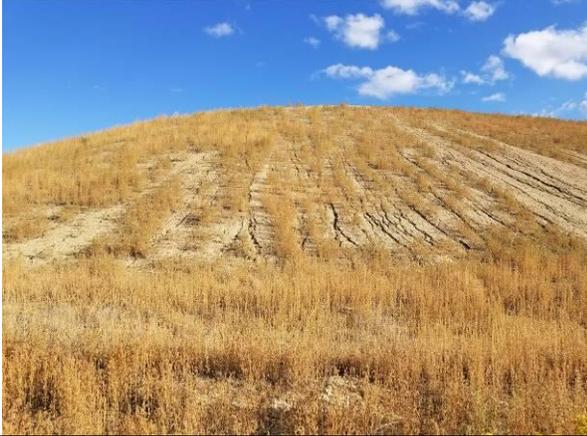
Photo #7 Facing North (Prior to Repair)

During our initial site visit, we observed a moderate amount of erosion rills and gullies along a portion of the southern slope. Most of the erosion features were about 6 to 8 inches deep, or less. The areas of erosion rills were located at the south facing slope surface in the southwest area of the fly ash portion of the landfill (see Photos # 7 to 9 in the attached photography log). The erosion rills were subsequently repaired, see Section 3.5 for details.

We recommended to UTILITIES representatives that the slope with erosion features (rills and gullies) in the area of Photos 7 through 9 should be filled and re-graded. On December 14, 2021, UTILITIES provided photographs (Photo # 56 - 60) showing the deficient area described in the Observations Section of this report had been repaired.
