4172 Center Park Drive  
 Colorado Springs, Colorado 80916  
 (719) 597-2116  
[Terracon.com](http://Terracon.com)

January 16, 2024

**RE:** Coal Combustion Residual (CCR) Landfill Annual (2023) Inspection  
 Clear Spring Ranch  
 Fountain, Colorado  
 Terracon Project No. 23155030

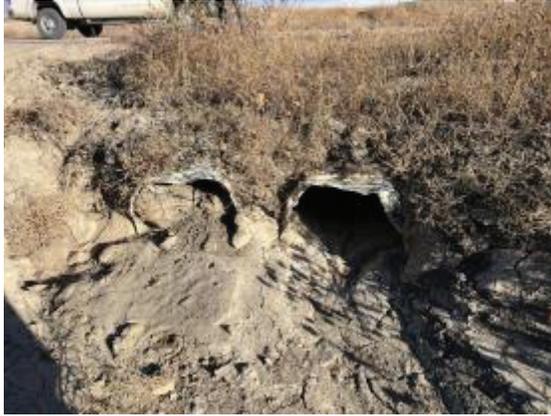
Photo No. 67, 10.26.23 Observations

During our initial site visit, we observed a significant amount of erosion rills and gullies along two areas of the southern slope. Most of the erosion features were about 6 to 10 inches deep. The areas of erosion rills were located at the south facing slope surface in the southeast area of the fly ash portion of the landfill (see Photo Nos. 13 to 17 and 24 to 28 in the attached Photo Location Diagram and Photography Log). In addition, we observed one of the two culverts at Photo No. 67 to be completely filled with sediment and the other partially filled with sediment.

- Two areas along the south facing slope developed localized areas with rills extending up to 10 inches through the 12-inch soil cap. These areas should be regraded to establish a uniform 12-inch soil cap.
- The two culverts near Photo No. 67 were mostly clogged with sediment from previous storm events. We recommended the culverts be cleaned to remove the sediment.

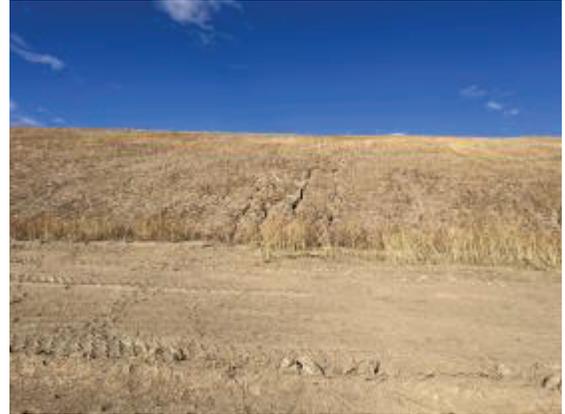
Photo No. 77, 12.21.2023 Observations

On December 21, 2023, Terracon completed a second site visit and observed portions of the southern slope had been regraded to fill gullies, however there still remained areas with 6 to 10-inch deep gullies (see Photo Nos. 77 to 79, 80 and 81). In addition, the previously mentioned Culvert was still filled with sediment (see Photo No. 85). The remaining south slopes were mitigated near the end of December as shown in Photo Nos. 86 to 90 provided by UTILITIES representatives. The culverts were cleaned of sediment on January 2, 2024 as shown in Photo Nos. 91 to 94 also provided by UTILITIES representatives.
