**RE:** Coal Combustion Residual (CCR) Landfill Annual (2025) Inspection  
Clear Spring Ranch  
El Paso County, Colorado  
Terracon Project No. 23155030

**CCR Landfill Annual Inspection, 2025**

Clear Spring Ranch | El Paso County, Colorado

January 15, 2026 | Terracon Project No. 23155030

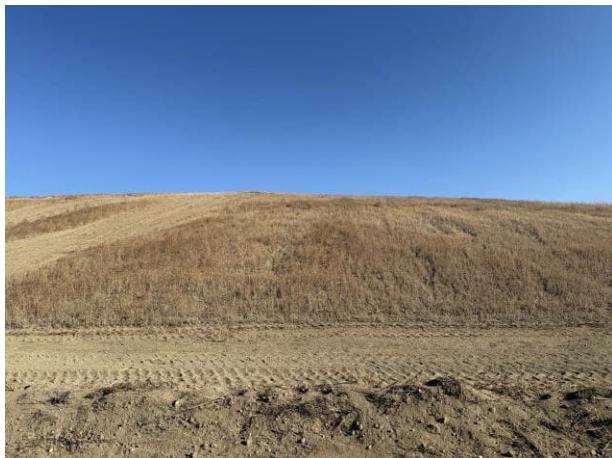
Photo No. 7, 10.22.2025 Observations

During our initial site visit on October 22, 2025, rills of about 4 to 6 inches in depths were observed at discrete locations along the south and southeast portions of the Fly Ash Landfill (see Photo Nos. 7 and 14 in the attached Photo Location Diagram and Photography Log) as well as the western section of the Bottom Ash Landfill (see Photo Nos. 17 through 20 in the attached Photo Location Diagram and Photography Log). The containment berms were observed to be intact and approximately 12 to 18 inches in height. In addition, the two culverts at the northern end of the landfill were observed to be clear and free of obstructions (see Photo Nos. 32, 33, and 37 in the attached Photo Location Diagram and Photography Log).

- Two areas along the south facing slope portion of the Fly Ash Landfill and one area along the western portion of the Bottom Ash Landfill developed localized areas with rills extending up to about 6 inches through the 12-inch soil cap. These areas should be regraded to establish a uniform 12-inch soil cap.

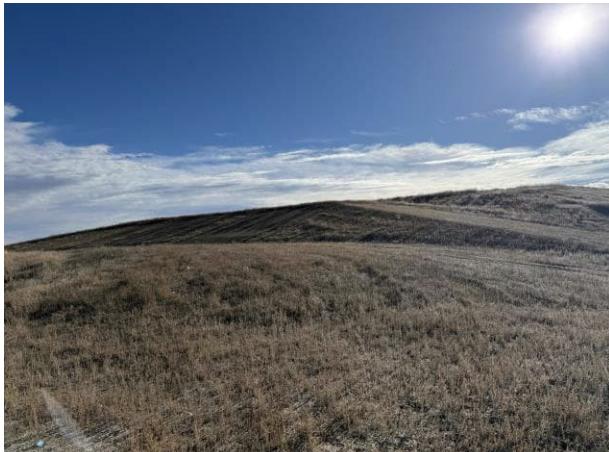
Photo No. 39, 11.19.25 Observations

On November 19, 2025, Terracon completed a second site visit and observed the identified portions of the southern and western slopes had been regraded to fill gullies (see Photo Nos. 39 to 49 in the attached Photo Location Diagram and Photography Log).
