## Energy Audit Case Study

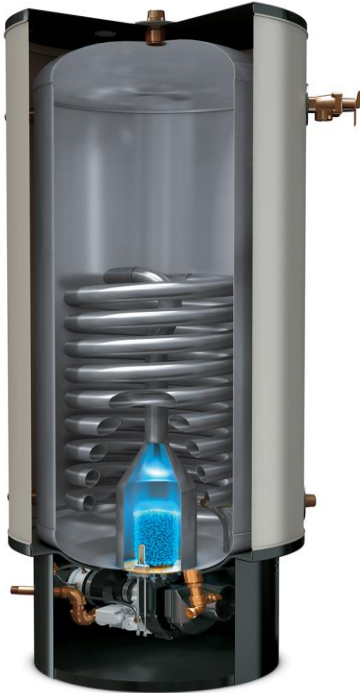
Image: bodenplumbing.com

This facility had an old industrial water heater and remote tank. The design was very heavy and showed no signs of wearing out, but the efficiency was terrible. Measurements showed high stack temperature, and there were high standby losses because the tank had no insulation. A condensing water heater with heavily insulated tank offered annual savings of 20-40% depending on usage. Rather than replacing with equal size and capacity, the design duty of the heater was reviewed. The original design calculations from the 1960's were not available, so the sizing was based today's requirements for hot water. All of the
