4172 Center Park Drive  
 Colorado Springs, Colorado 80916  
 (719) 597-2116  
[Terracon.com](http://Terracon.com)

January 16, 2024

**RE:** Coal Combustion Residual (CCR) Landfill Annual (2023) Inspection  
 Clear Spring Ranch  
 Fountain, Colorado  
 Terracon Project No. 23155030

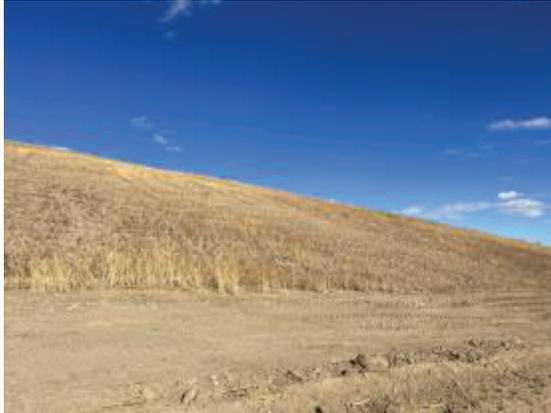
Photo No. 78, 12.21.2023 Observations

On December 21, 2023, Terracon completed a second site visit and observed portions of the southern slope had been regraded to fill gullies, however there still remained areas with 6 to 10-inch deep gullies (see Photo Nos. 77 to 79, 80 and 81). In addition, the previously mentioned Culvert was still filled with sediment (see Photo No. 85). The remaining south slopes were mitigated near the end of December as shown in Photo Nos. 86 to 90 provided by UTILITIES representatives. The culverts were cleaned of sediment on January 2, 2024 as shown in Photo Nos. 91 to 94 also provided by UTILITIES representatives.

- Two areas along the south facing slope developed localized areas with rills extending up to 10 inches through the 12-inch soil cap. These areas should be regraded to establish a uniform 12-inch soil cap.
- The two culverts near Photo No. 67 were mostly clogged with sediment from previous storm events. We recommended the culverts be cleaned to remove the sediment.
