January 12, 2023

RE: Coal Combustion Residual (CCR) Landfill Annual (2022) Inspection
 Clear Spring Ranch
 Fountain, Colorado
 Terracon Project No. 23155030

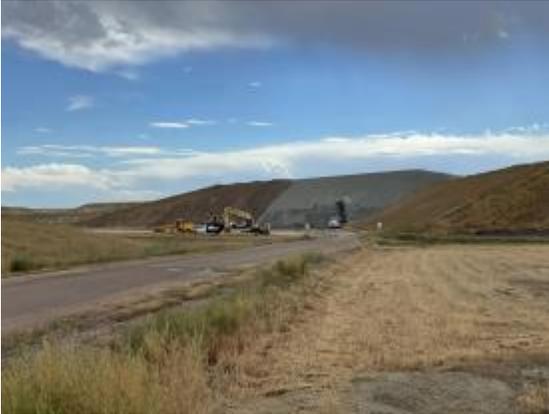
Photo No. 55

Direction: S. Lat: 38.6108 Long: -104.7093

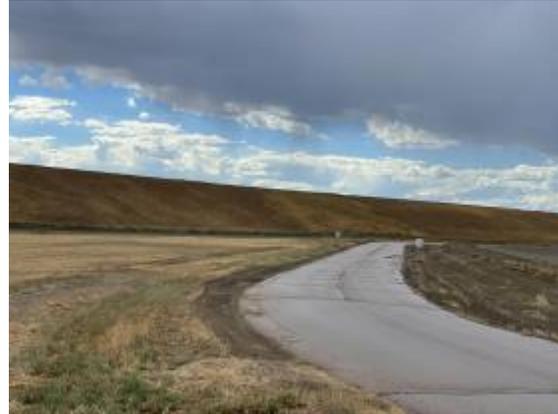
Photo No. 56

Direction: SW. Lat: 38.6107 Long: -104.7093
